Manhole Inspection Summary

Manhole # S53G__022MH

Insp Date: **4/15/08 9:43 AM**

Location Address: **3211 E Pratt St**

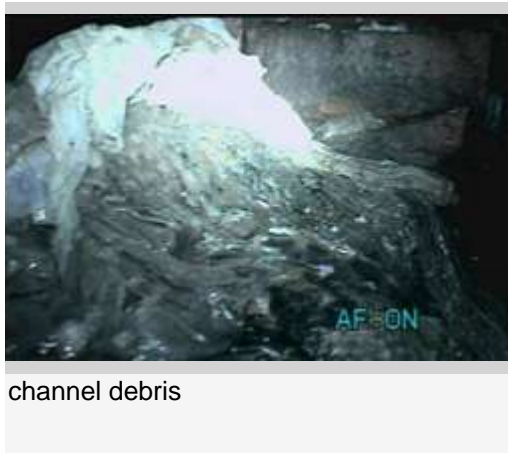
Defect 3

Condition: ☐ Sound ☐ Cracked ☐ Root Intrusion ☐ Deteriorated ☐ Leaks ☒ **Debris**

channel debris

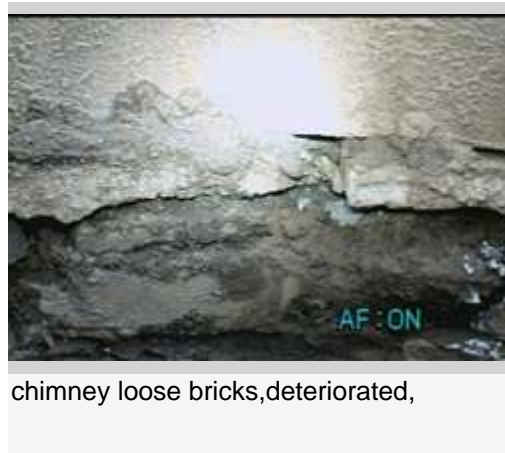
Defect 2

Condition: ☐ Sound ☒ **Cracked** ☐ Root Intrusion ☒ **Loose Brick** ☐ Deteriorated

chimney loose bricks,deteriorated,

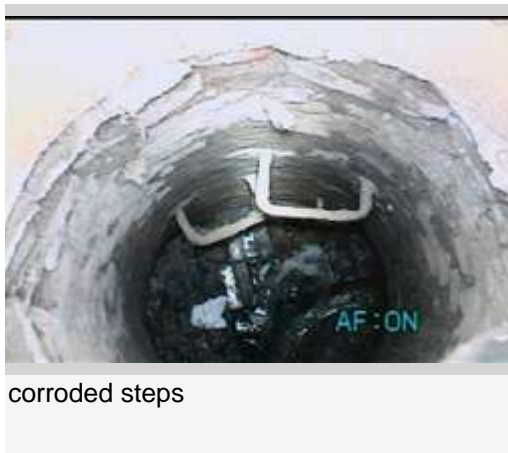
Defect 1

Steps Count: **4** Missing: **1** ☒ **Corroded**

corroded steps
